Mahurangi Land Restoration Programme

Te Muri Sub-Catchment Action Plan 2023

Published September 2023

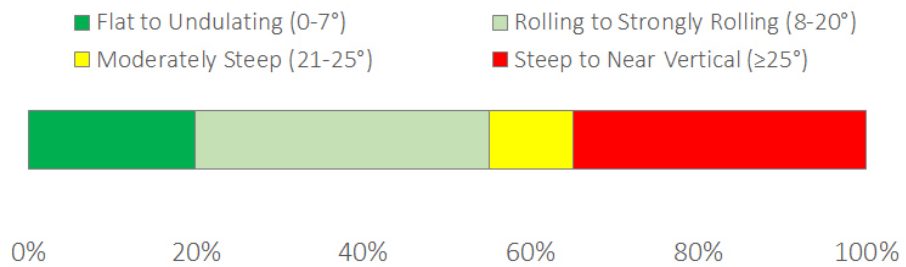
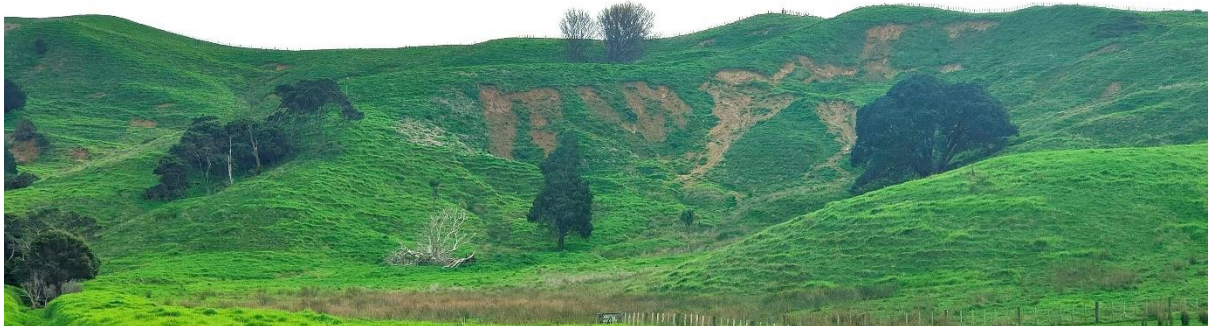
Photo showing surface erosion on hill country, exacerbated by cyclones in summer 2023

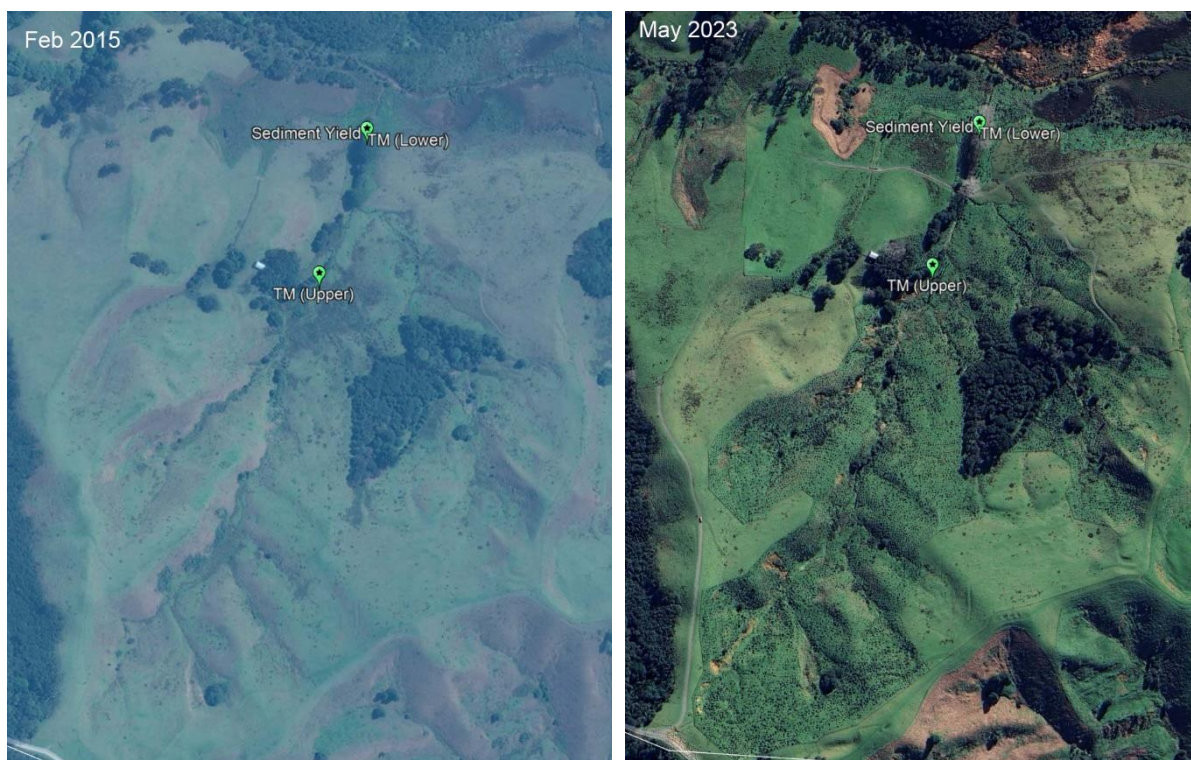
Changing Land Cover - Te Muri Regional Park has significant areas managed under low intensity drystock farming. Over the last seven years, approximately 100 ha of steep, erosion-prone land has been retired from grazing and planted in mixed native vegetation. This land use change is not well represented by national land cover data but is clearly visible from in the below satellite imagery of a Te Muri Stream tributary.

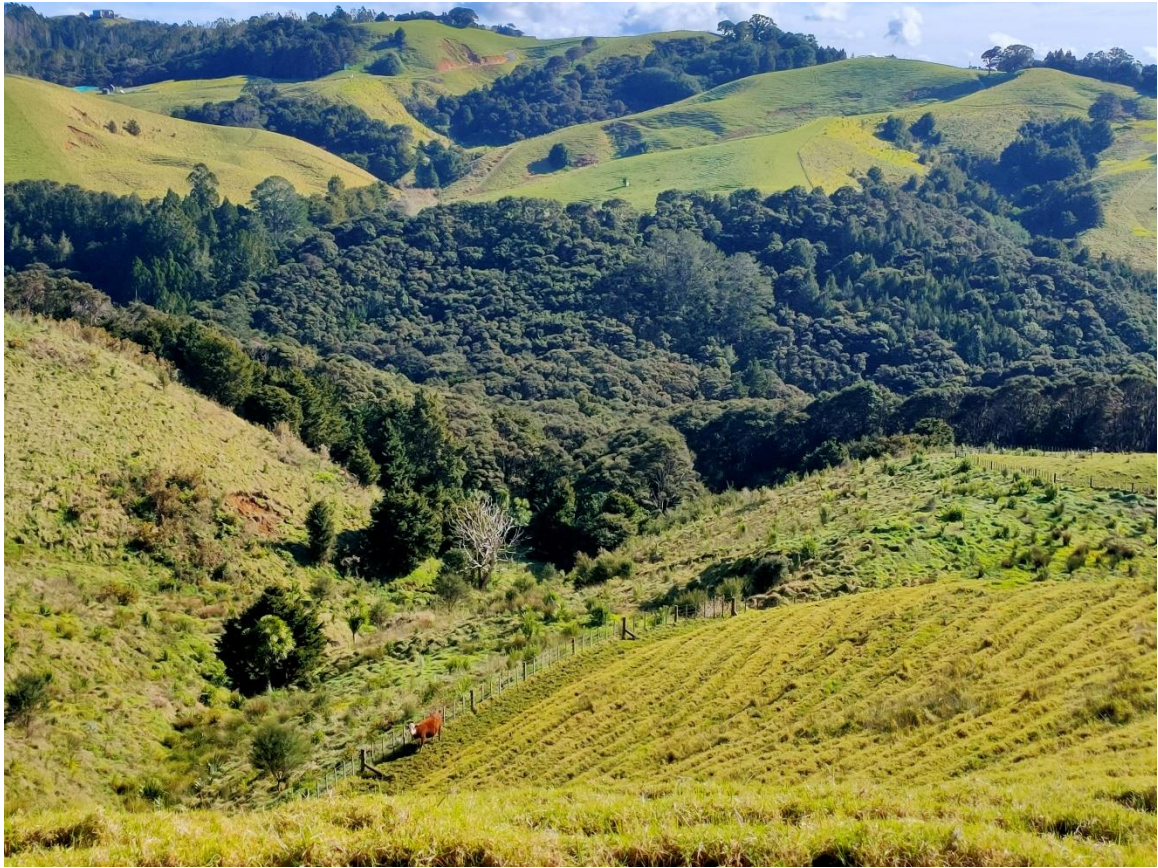
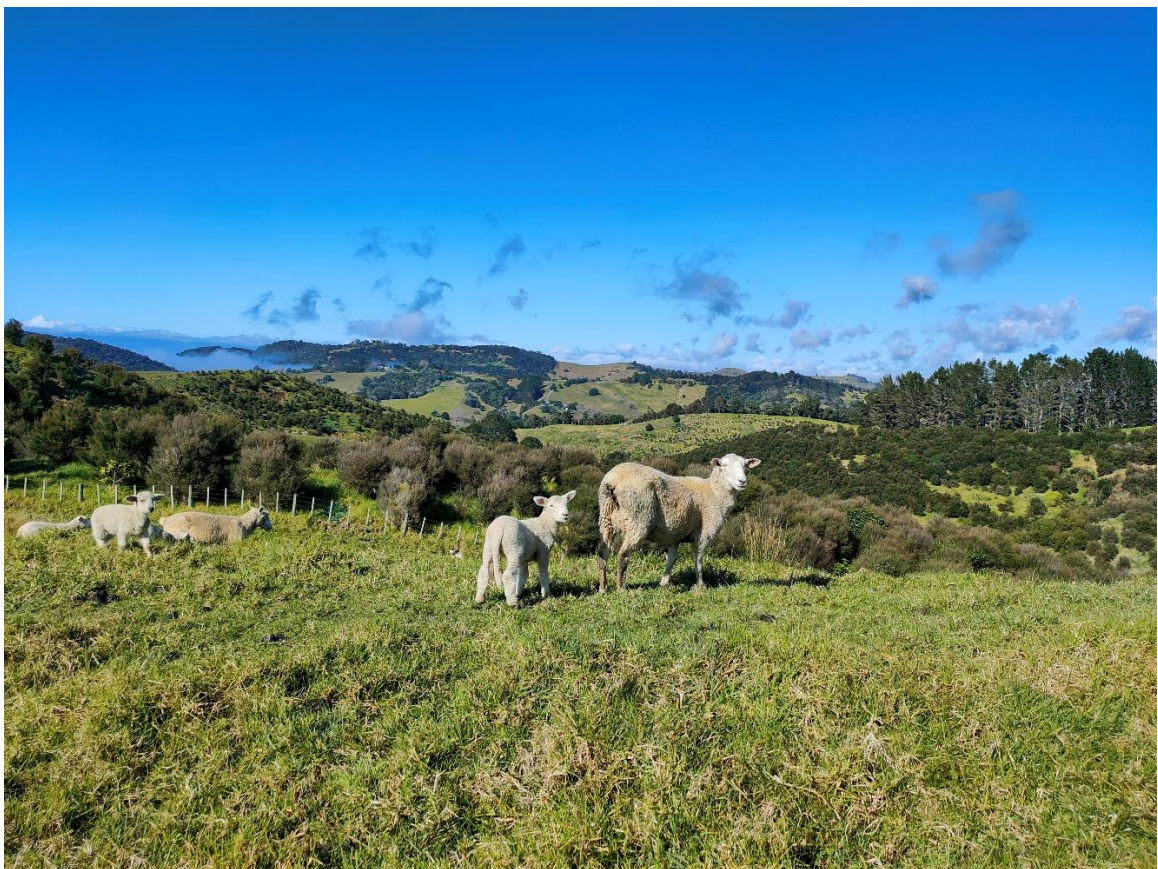
Photos from Te Muri Regional Park showing livestock grazing outside retired gullies.

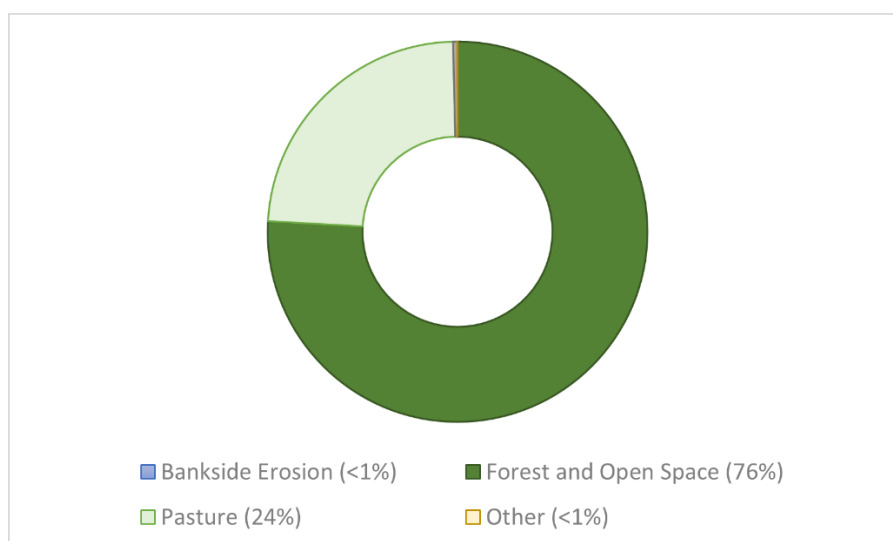
Estimated Average Annual Sediment Load by Land Cover (Tonnes/year)

Te Muri has the fourth highest estimated average annual sediment yield (799 tonnes/km²/yr) of all sub-catchments surrounding the harbour. In relation to land cover, forests and open space accounts for the highest sediment contribution (76%) followed by pasture (24%) with a small amount attributed to bank erosion and other sources (<1%).
